(Town of Killingworth Inland Wetlands and Watercourses Commission Killingworth, Connecticut 06419

ON SITE WALK-THRU MINUTES

3:40 P.M. May 20, 2025 Application W-43 Map 28, Lot 59A Owner Jack B. Coy LLC, Applicant Michael Berkun 275 Roast Meat Hill Road

Construction or installation of two sheds 4' x 8', one shed 10' x 12' and one shed 10' x 12' proposed for use for the operation, management, conservation, improvement and maintenance to the operation of the farm and nursery association with 2-acre farm pond. (Farm pond currently under construction)

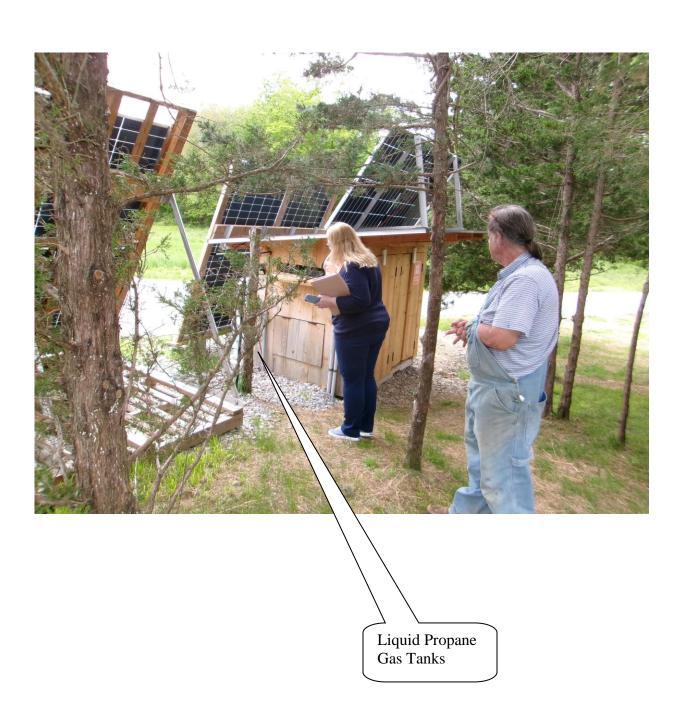
PICTURE NO. 1 - LOCATED AT THE SOUTH-CENTRAL PORTION THE SITE LOOKING IN A SOUTHERLY DIRECTION AT 4' X 6' WOOD UTILITY SHED AND SOLAR ARAY; SHED USED TO HOUSE SOLAR BATTERIES THAT POWER FARMHOUSE AND EMERGENCY POWER GENERATOR

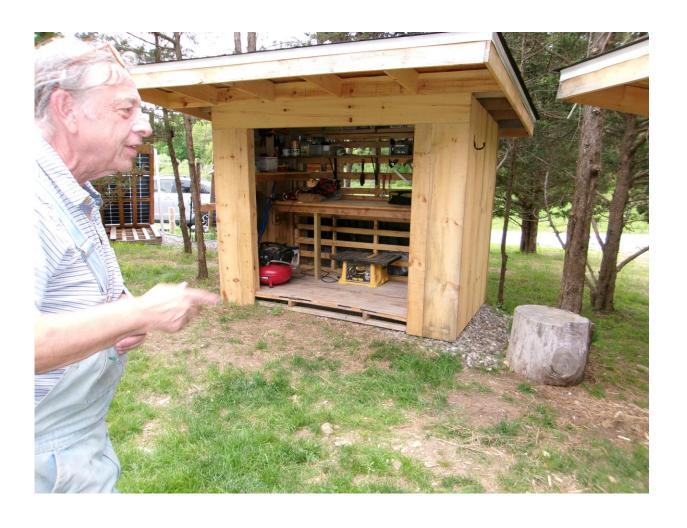
PICTURE NO. 2 LOOKING AT 4' X 8' UTILITY SHED USED TO HOUSE GENERAL FARM TOOLS

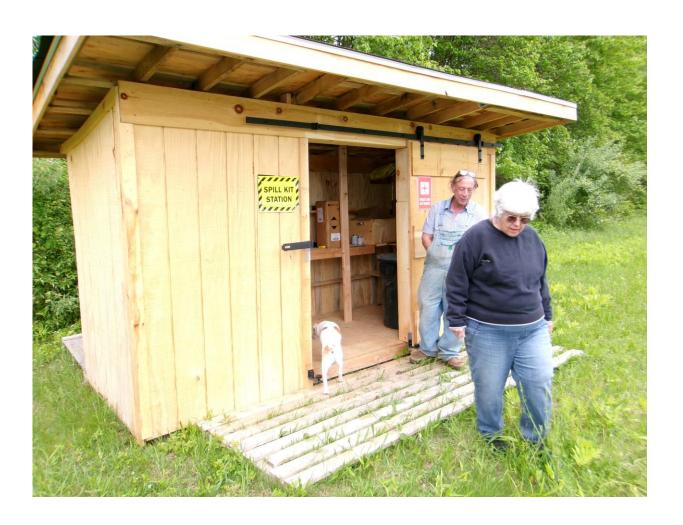
PICTURE NO. 3 LOOKING AT 4' X 10' UTILITY SHED USED TO HOUSE EMERGENCY SPILL CONTAINMENT AND MISCELANOUS EQUIPMENT FOR FARM POND CONSTRUCTION

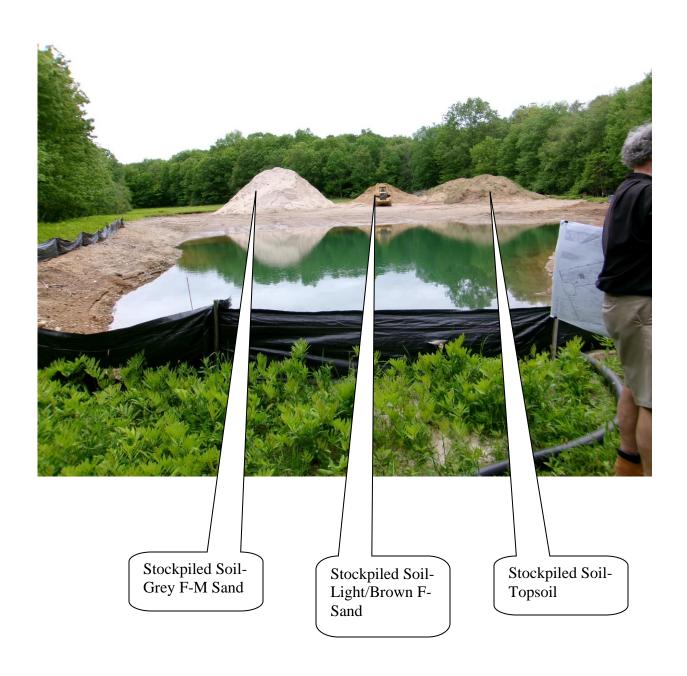
The Walk-Thru team then proceeded to the location of the previously approved farm pond located at the northeastern portion of the site (See Picture No, 4) which has been under construction since late December of 2024.

The water within the pond was observed to be crystal clear and a deep blue in color. Excavated soil has been stockpiled in 3 different piles according to the type and grain size distribution. (1) A blackish brown topsoil for later placement on site. (2) A Light Brown Fine Sand, for removal off-site and (3) A Grey Fine to Medium Sand for removal off-site.

A silt fence surrounded all work areas and there was no evidence of erosion into wetlands or buffering areas.

A 3" discharge pump has been set-up at the northern end of the pond; its use is for the dewatering of the pond while excavation proceeds. Discharge has been clear water and is directed towards a well vegetated area.

The pond is being excavated to a 15' depth and is only partially complete at this time.

PICTURE NO. 4 LOOKING AT FARM POND UNDER CONSTRUCTION -LOOKING DUE NORTH
