ON SITE WALK-THRU MINUTES

**September 11, 2025**

**Wetlands and probable vernal pool incursion violation**

**14 Bethke Road Hill Road**

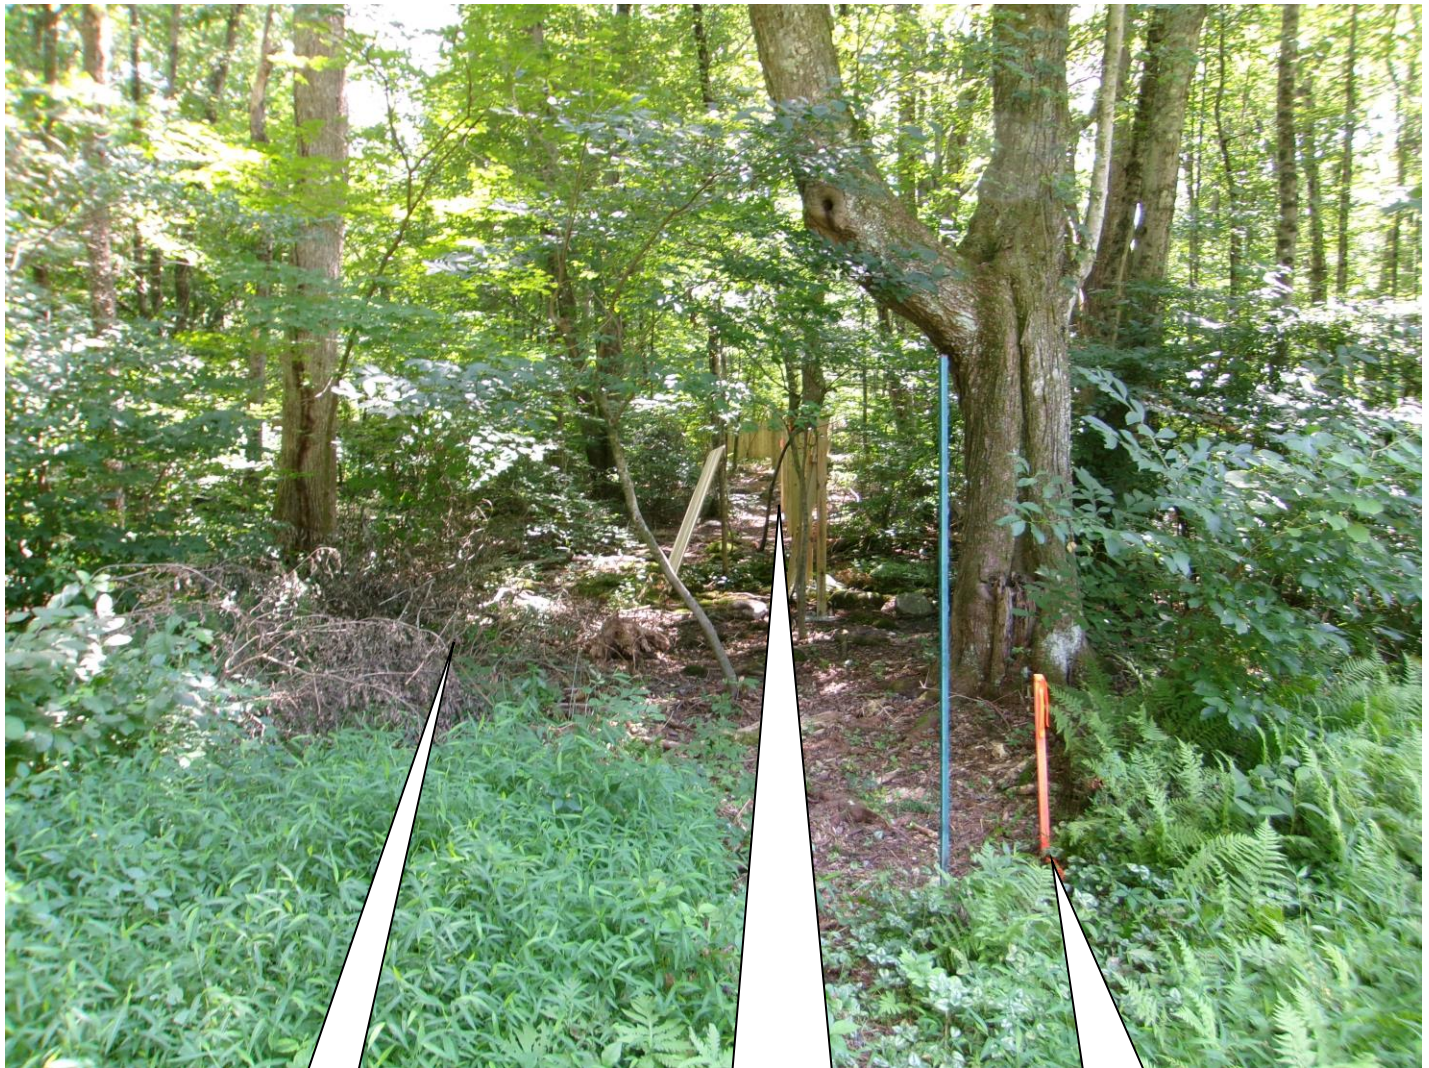
**PICTURE NO. 1 - LOCATED AT THE SOUTH-EAST PROPERTY CORNER OF 14 BATHKE ROAD-  
LOOKING IN A NORTHEASTERLY DIRECTION AT FENCE POST WHICH WAS FLAGGED AS  
PROPOSED NEW CORNER OF FENCE**

Inland Wetlands

Approximate location of 4<sup>th</sup> from last fence post which had been constructed where flagging was placed.

Surveyed Property Boundary – Southwest Corner, 14 Bethke Road

been placed on a fence post (fencing had not been installed on the posts as yet) which represented the fourth from last fence post that had been installed (approximately 70 feet southeast of the southwest property corner. From these two flagged locations an additional flag was placed at t approximate midpoint between the two points. These 3 points established a line running from south to north which it was the commission's recommendation for the new alignment for the fence construction. It was noted that once the new alignment has been staked, the commission should be notified so that an inspection can be made.
