SPECIAL MEETING AND ON-SITE WALK-THRU MINUTES

Wetlands and probable vernal pool incursion violation

14 Bethke Road Hill Road

Construction and installation of 6' high opaque wood fence in inland wetlands and adjacent to an apparent vernal pool.

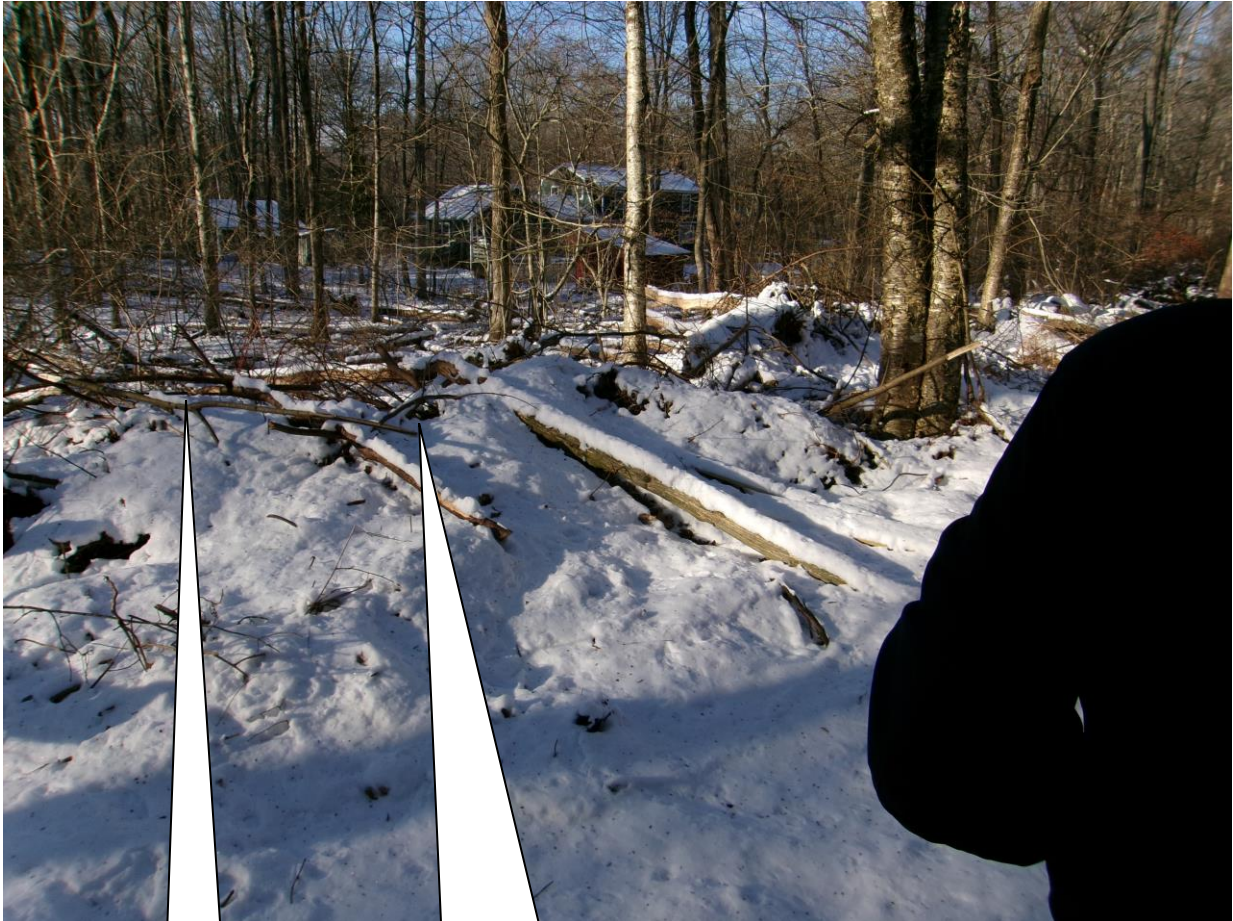
PICTURE NO. 1 - LOCATED AT THE SOUTH-WEST FENCE LOCATION LOOKING IN A NORTHWESTERLY DIRECTION JUST OUTSIDE OF FENCE LOCATION

The commission proceeded to an area located just outside of the fenced in area located at the northwest portion of the site which is considered to be wetlands. We observed a pile of some cut brush and a tree blow down (See Picture No. 1). It was the commission's consensus that this material could remain in place, but it was strongly stated that additional material should not be placed at this location.

Inland Wetlands

Looking at blow downs and some of the brush that was cut during the fence construction

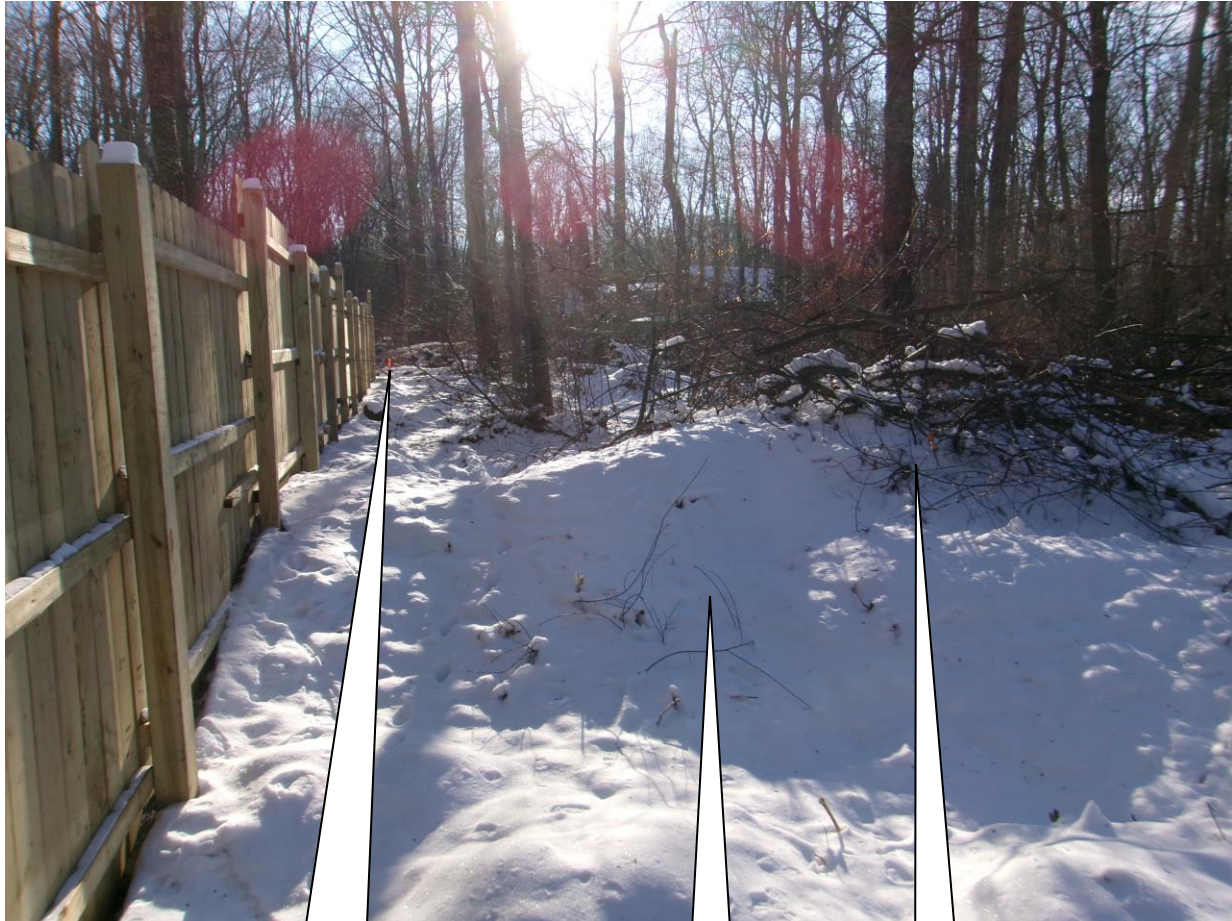
PICTURE NO. 2 - LOCATED AT THE SOUTH-WEST FENCE LOCATION -LOOKING IN A SOUTHWESTERLY DIRECTION JUST OUTSIDE OF THE FENCED IN AREA

Property Line
Boundary Marker

Inland Wetlands

Brush from a
fallen down tree

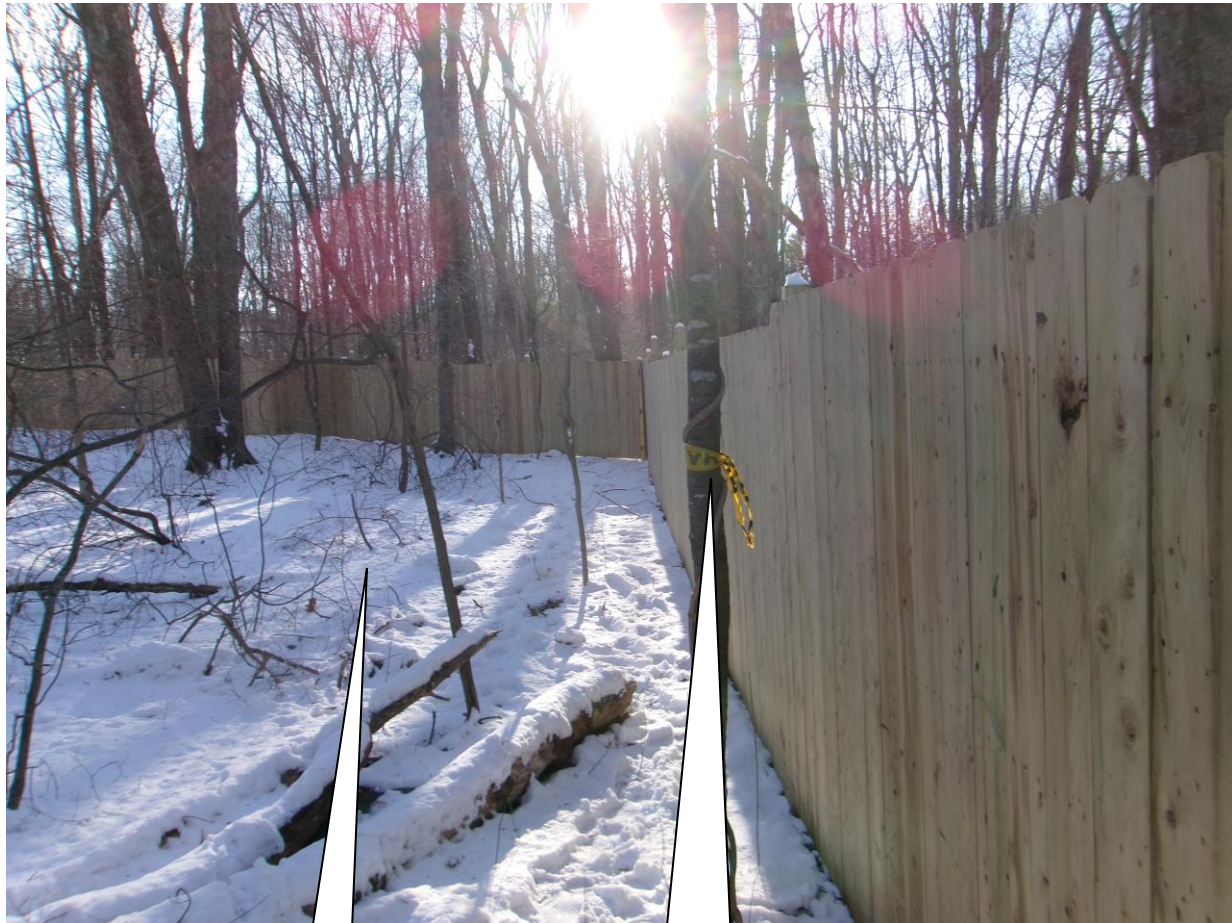
PICTURE NO. 3 - LOCATED AT THE SOUTH-WEST FENCE LOCATION-LOOKING IN A NORTHWESTERLY DIRECTION JUST INSIDE OF FENCE

Inside of fence
area

Marker placed by
commission during the
Sept. 11 Walk-Thru
