Town of Killingworth
Inland Wetlands and Watercourses Commission
Killingworth, Connecticut 06419

ON SITE WALK-THRU MINUTES

Application W-45, July 8, 2025

**137 Cow Hill Road, Map 40, Lot 2- David Vieau (owner), T.A. Stevens and Assoc., Inc.
(applicant)**

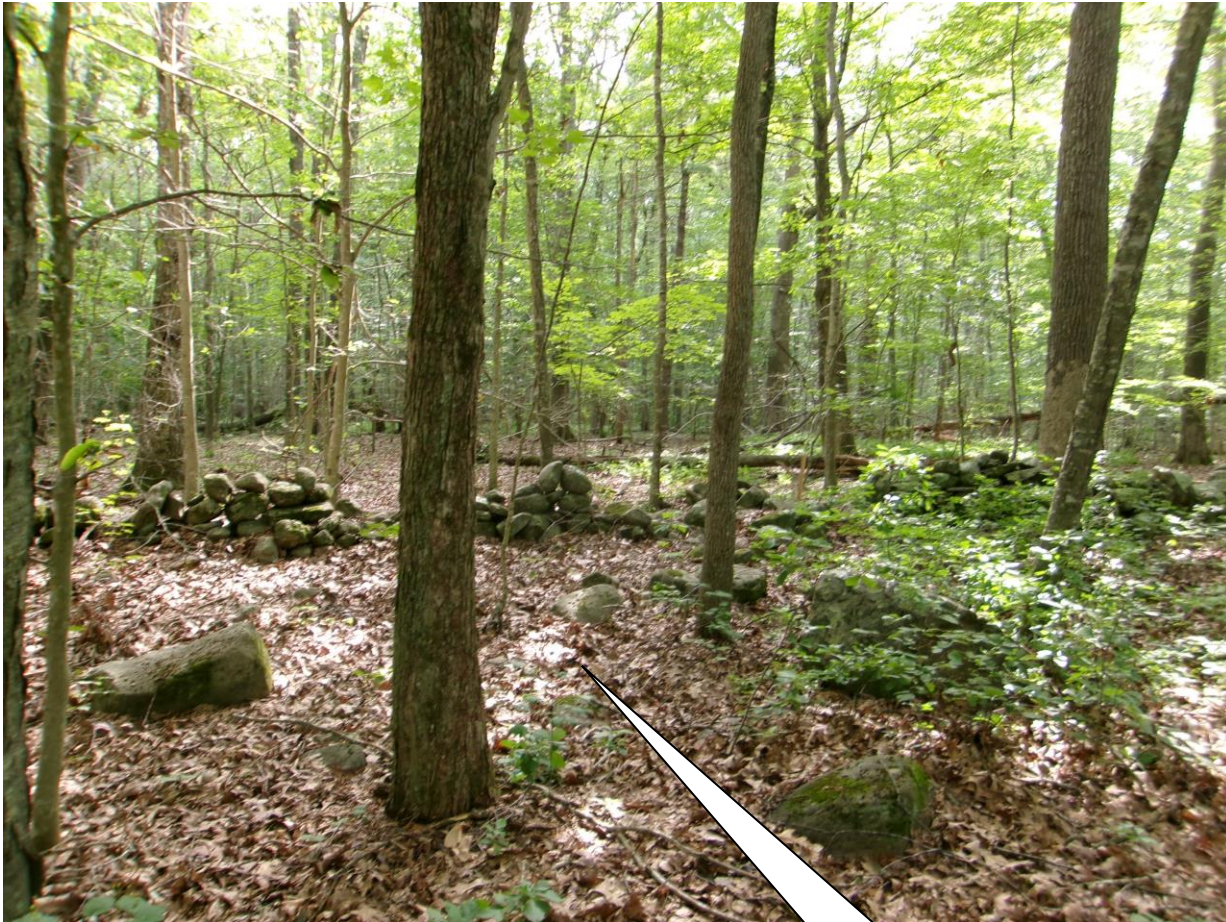
PICTURE NO. 1 LOOKING AT PROPOSED LOCATION OF DRIVEWAY ENTRANCE

The present site is undeveloped consisting of mature hardwoods growth with little understory. There are many stone walls located throughout the property indicating that the property was used for agricultural and farming purposes in its past (See Picture 1 attached).

PICTURE WAS TAKEN STANDING ON COW HILL ROAD LOOKING WEST INTO THE PROPERTY

Proposed Location of
entrance driveway

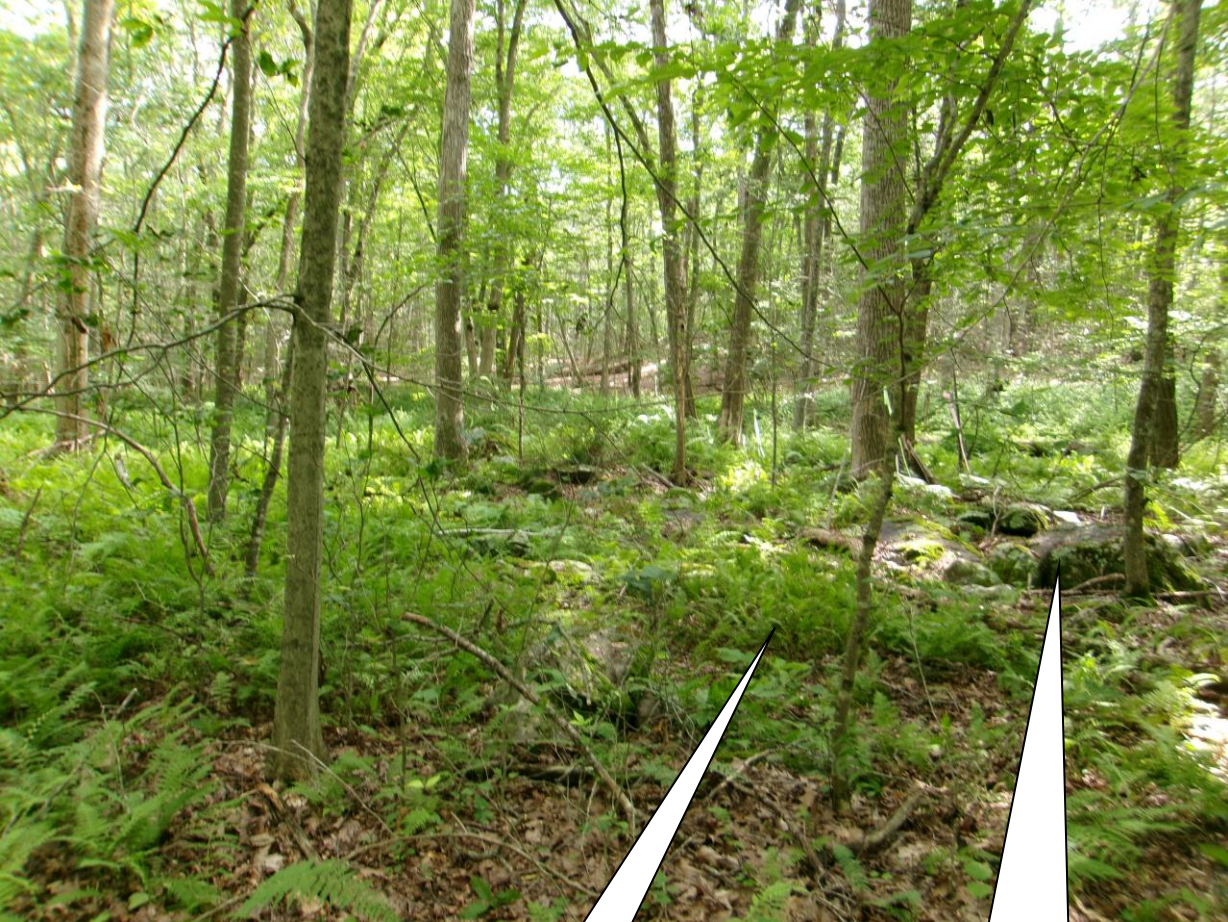
PICTURE NO. 2 LOOKING AT WETLAND DESIGNATED AREA AT LOCATION OF PROPOSED DRIVEWAY AND CULVERT LOCATION (LOOKING WEST)

The wetland crossing area is wooded and has firm soil with many boulders of various sizes located at or near ground level. The understory is well vegetated. The surface is not inundated and is firm to walk on. (See Picture No. 2). The surface vegetation consists of mostly ferns.

Fern understory

Large surface boulder located within wetlands

Glenn Johnson asked if a bottomless culvert for the driveway crossing could be considered. Thomas Stevens not too long ago used one for a crossing for the Old Stagecoach Road subdivision here in Killingworth which was recommended by this commission. This was for a stream crossing unlike the dry crossing that is currently being proposed. Chuck Mandel agreed to consider this alternative.
